Intel[®] Xeon[™] Processor MP

Specification Update

August 2002

Document Number: 290741-006

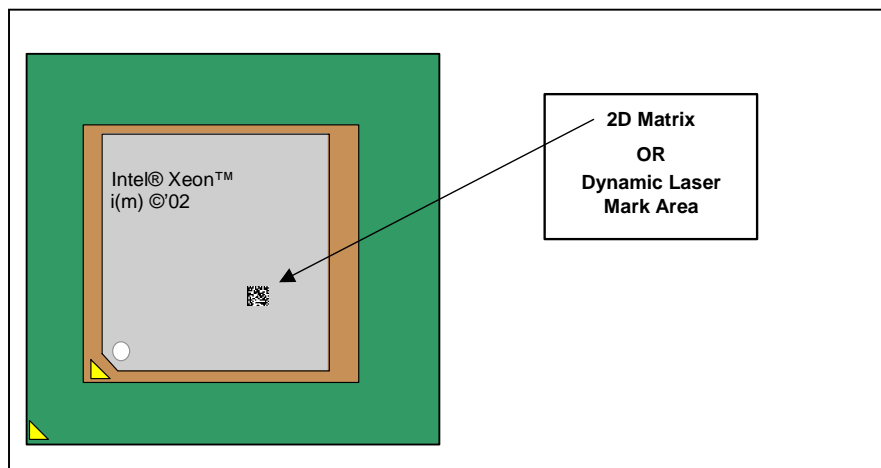
Figure 1. Top-Side Processor Marking – Production Part

Intel® Xeon™ Processor MP Markings (603-pin INT-mPGA)
